CANISTEAR RESERVOIR DAM

NO 1

NJ 00485

**PHASE 1 INSPECTION REPORT
NATIONAL DAM SAFETY PROGRAM**

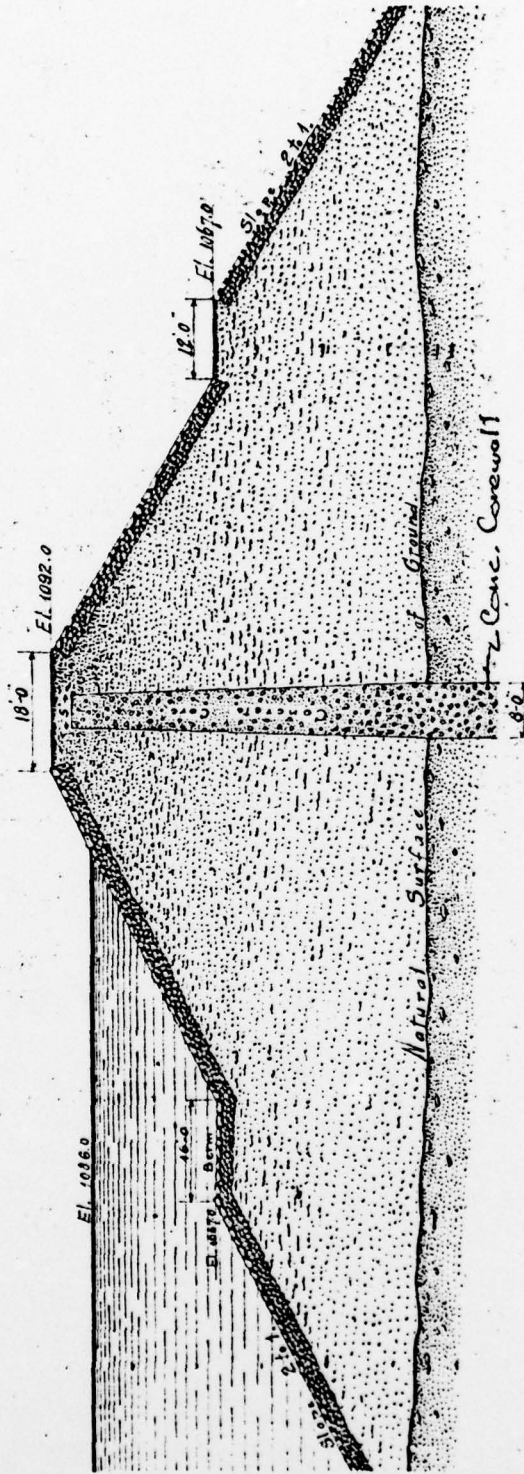
FIGURE 4

Profile of Cantstear Dam No. 1
